New Hampshire Volunteer Lake Assessment Program

2003 Interim Report for Big Island Pond Derry

NHDES
Water Division
Watershed Management Bureau
29 Hazen Drive
Concord, NH 03301

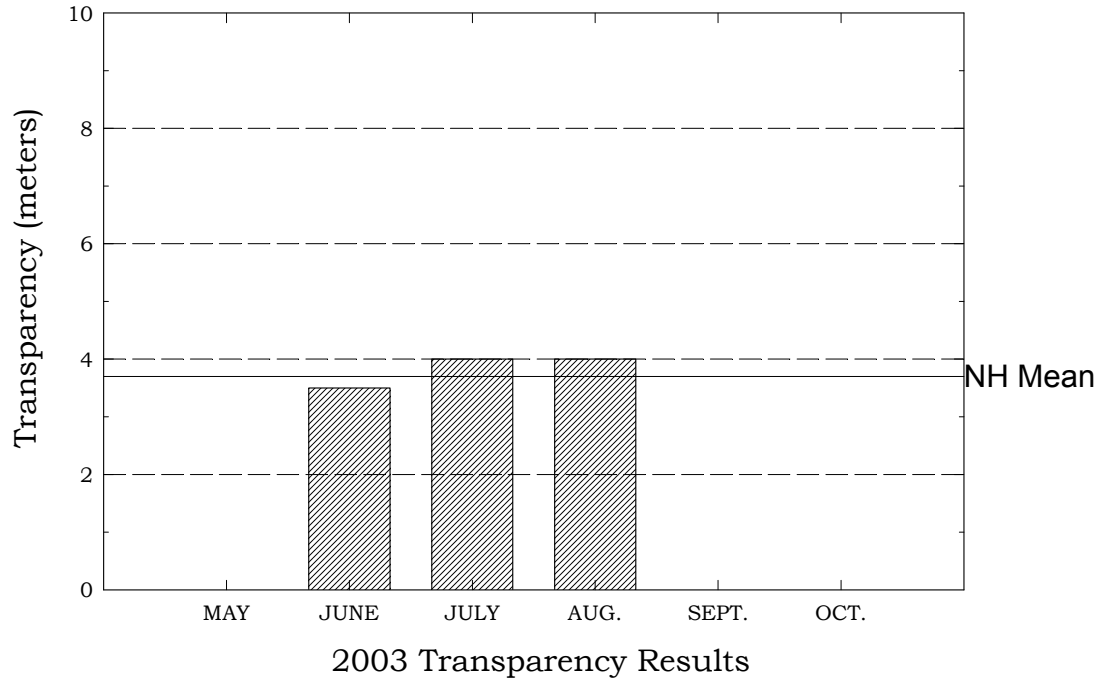
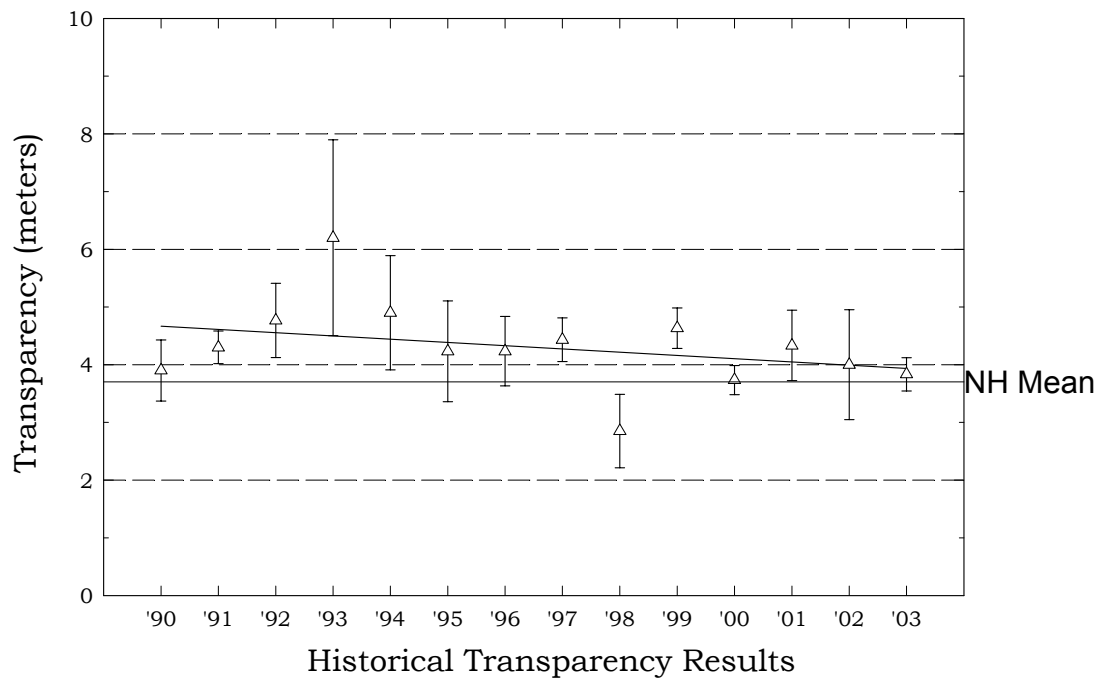
Figure 2. Monthly and Historical Transparency Results

The current year data (the top graph) show that the in-lake transparency **increased** from June to July, and then **remained stable** from July to August. The transparency in June was **slightly less than** the state mean, while the transparency in July and August was **slightly greater than** the state mean.

The historical data (the bottom graph) show that the 2003 mean transparency is **approximately equal to** the state mean.

Overall, visual inspection of the historical data trend line (the bottom graph) shows a **relatively stable** trend for in-lake transparency, meaning that the transparency has **remained approximately the same** (aside from data collected in 1993 and 1998) since monitoring began. As discussed previously, in the 2004 annual report, we will conduct a statistical analysis of the historic data to objectively determine if there has been a significant change in the annual mean transparency since monitoring began.

Typically, high intensity rainfall causes erosion of sediments into lakes/ponds and streams, thus decreasing clarity. Efforts should continually be made to stabilize stream banks, lake/pond shorelines, disturbed soils within the watershed, and especially dirt roads located immediately adjacent to the edge of tributaries and the lake/pond. Guides to Best Management Practices designed to reduce, and

possibly even eliminate, nonpoint source pollutants, such as sediment loading, are available from DES upon request.

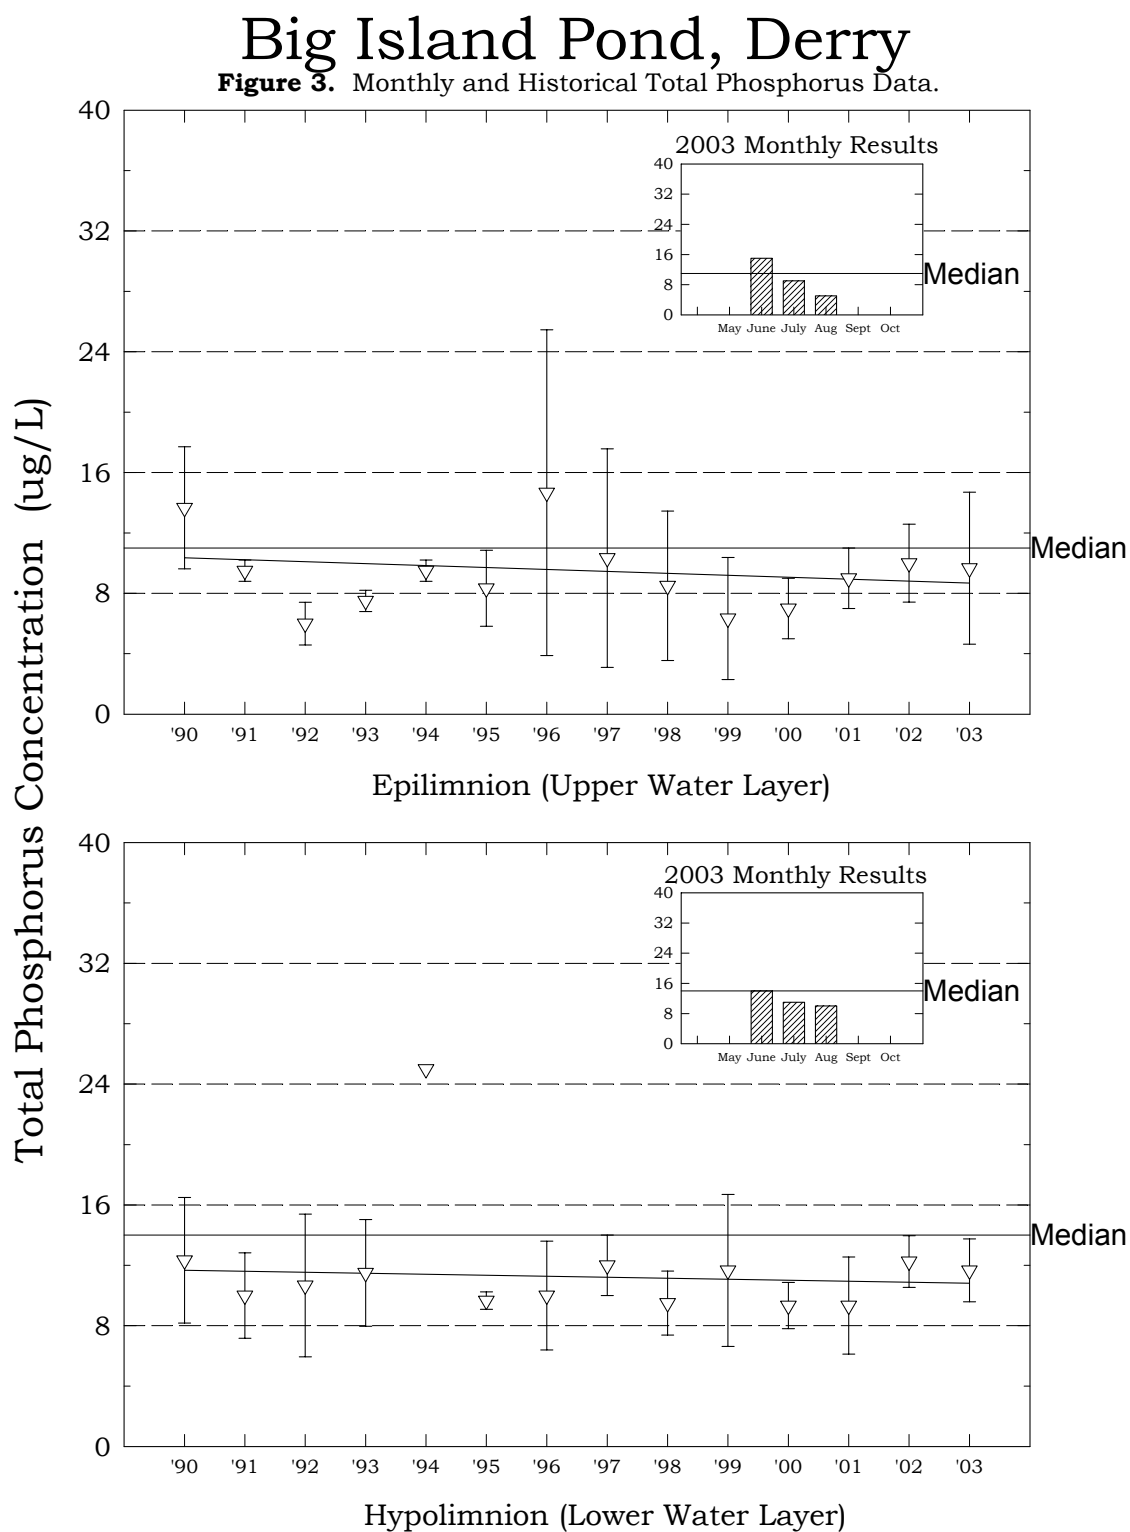
The current year data for the epilimnion (the top inset graph) and the hypolimnion (the lower graph) show that the phosphorus concentration **decreased** from June to August.

The historical data show that the 2003 mean epilimnetic and hypolimnetic phosphorus concentration is **slightly less than** the state median.

Overall, visual inspection of the historical data trend line for the epilimnion shows a **fluctuating** phosphorus trend, which means that the concentration has **varied, but has not continually increased or decreased**, since monitoring began.

Overall, visual inspection of the historical data trend line for the hypolimnion shows a **relatively stable** phosphorus trend, which means that the concentration has **remained approximately the same** (aside from data collected in 1994) in the hypolimnion.
